CHAPTER 4

Avalanche: Risks and Mitigation

4.1 Identifying and Profiling Avalanche Hazards

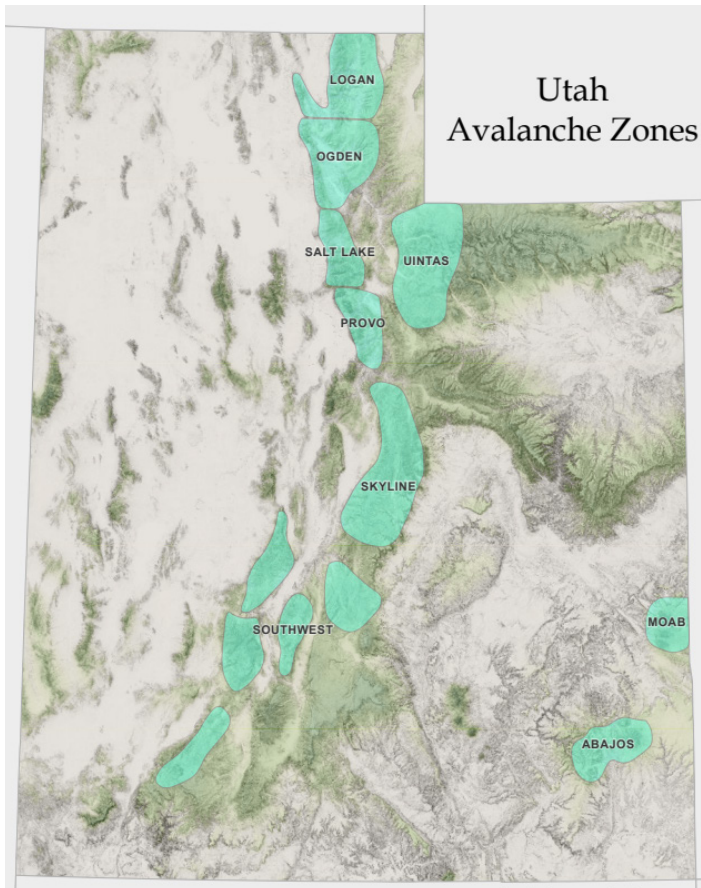
Map 1. Utah Avalanche Zones. Avalanche data: avalanche.org.

There are 9 major avalanche zones in Utah. These include: Logan, Ogden, Salt Lake, Provo, Uintas, Skyline, Southwest, Moab, and Abajos.

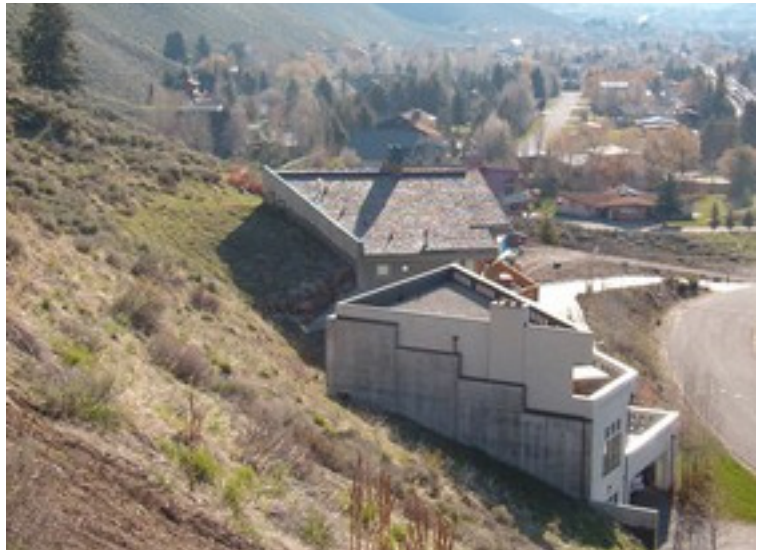
Direct protection structures are incorporated into the design of the building and safeguard an isolated structure to allow it to withstand the impact pressure of an avalanche. These structures are most effective on slopes of 12 to 20 degrees, steeper slopes generate high velocity avalanches which can overwhelm the structure.

Residential structure, Ketchum Idaho. Source: Chris Wilbur.

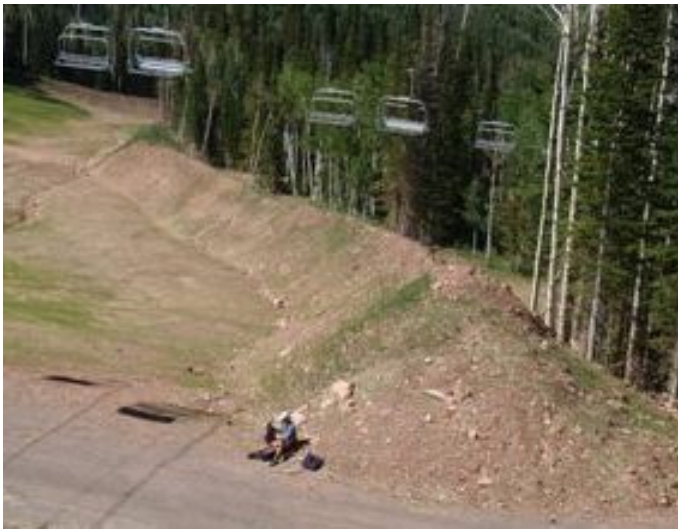
Deflecting structures are built with the intent of changing the flow of a slide to limit and redirect the avalanche's natural runout zone. An example of deflection is a splitting wedge which is a reinforced concrete or steel wedge designed to divert avalanches around either side of a structure. Channelizing is most effective on 12 to 20 degree slopes and is commonly used when multiple structures need to be protected.

Deflection Dam, Park City, Utah. Source: Chris Wilbur.

Items of significance in the 2019 plan include the construction of permanent structures like the snow deflection dam in Park City designed to limit the size of snow slides and stop small avalanches before they gain momentum and do significant damage. The Utah Department of Transportation (UDOT) protects road and railroad infrastructure by utilizing artillery and explosives to test snowpack stability and trigger small avalanches. Utah's ski resorts use helicopters and hand thrown explosives to mitigate avalanche dangers in their parks.

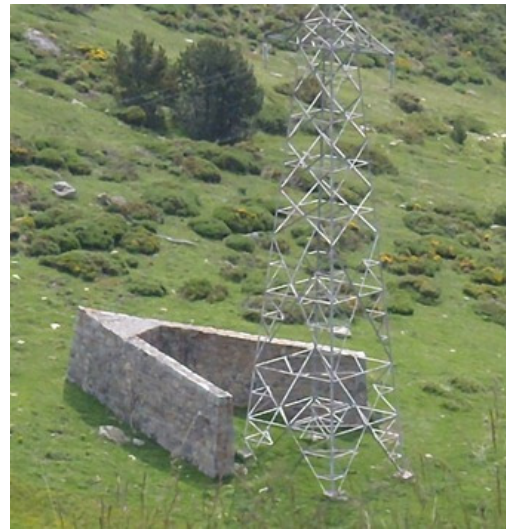
*Masonry Deflection Wedge, Val d'Aran, Spain.
Source: Chris Wilbur.*

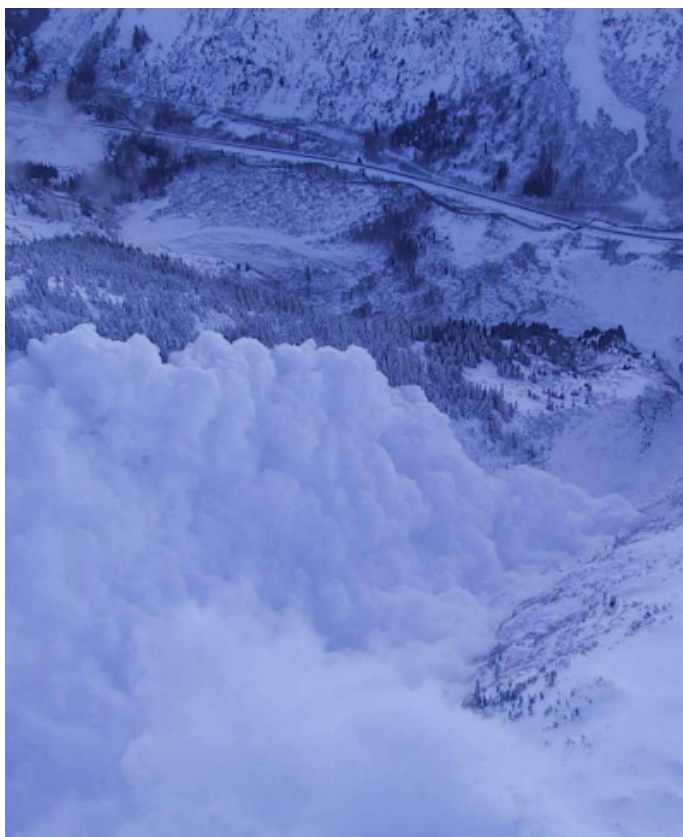
Helicopter avalanche control is useful in areas difficult to access when time constraints are a factor but there are limitations, helicopters can only fly under ideal weather conditions and officials must close roads around detonation zones. Most helicopter avalanche control work in Utah is utilized up Big and Little Cottonwood Canyons.

Dry slab avalanche with a significant powder component triggered using helicopter explosives. D. Wilson Photo¹³
